**DEPARTMENT OF TRANSPORTATION**

Contract #: 04-0120F4Cty: SF/ALA Rte: 80 PM: 13.2/13.9File #: 1.28**WELDING INSPECTION REPORT****Resident Engineer:** Siegenthaler, Peter**Address:** 333 Burma Road**City:** Oakland, CA 94607**Report No:** WIR-018862**Date Inspected:** 22-Dec-2010**Project Name:** SAS Superstructure**OSM Arrival Time:** 900**Prime Contractor:** American Bridge/Fluor Enterprises, a JV**OSM Departure Time:** 1730**Contractor:** American Bridge/Fluor Enterprises, a JV**Location:** Jobsite**CWI Name:** See below**CWI Present:** Yes No**Inspected CWI report:** Yes No N/A**Rod Oven in Use:** Yes No N/A**Electrode to specification:** Yes No N/A**Weld Procedures Followed:** Yes No N/A**Qualified Welders:** Yes No N/A**Verified Joint Fit-up:** Yes No N/A**Approved Drawings:** Yes No N/A**Approved WPS:** Yes No N/A**Delayed / Cancelled:** Yes No N/A**Bridge No:** 34-0006**Component:** SAS OBG**Summary of Items Observed:**

## WELDING INSPECTION REPORT

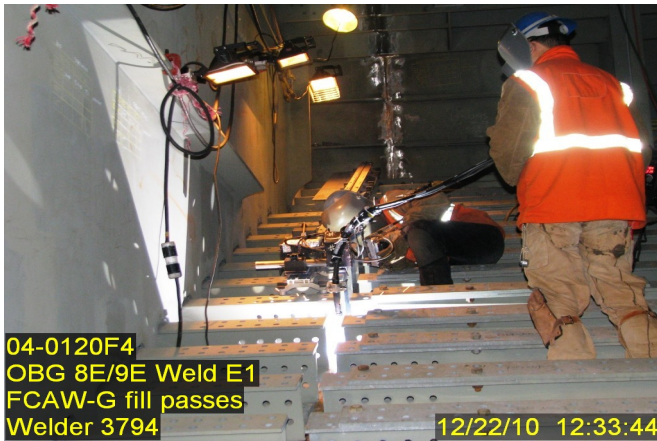
The QAI periodically observed AB/F approved welder Song Tao Huang (ID 3794) assisted by AB/F approved welder Jin Quan Huang (ID 9340) performing welding of fill and cover passes at the OBG Field Splice 8E/9E Weld ID: E1. See photo below. The welding was performed per the Flux Cored Arc Welding (FCAW-G) process in the 3G (vertical) position. The QAI observed QC Inspector Fred Von Hoff were present periodically to monitor the progress and verify that the welding parameters were within the limits established by the approved welding Procedure Specification (WPS) identified as ABF-WPS-D1.5-3042B-1. The welding of cover passes was completed. The QAI observed that the work at this location appeared to be in general compliance with contract documents.

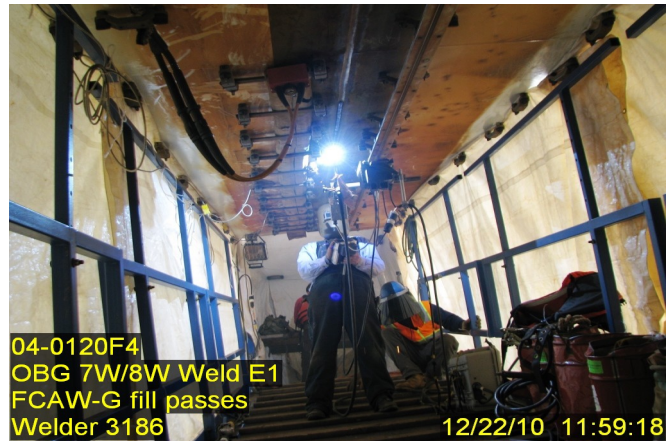
The QAI periodically observed AB/F approved welder Rory Hogan (ID 3186) assisted by AB/F approved welder Jeremy Dolman (ID 5042) performing fill and cover pass welding per the Flux Cored Arc Welding (FCAW-G) process in the 4G (overhead) position. See photo below. The QAI periodically observed QC inspector Steve McConnell was present to monitor the progress and verify that the welding parameters were within the limits established by the approved welding Procedure Specification (WPS) identified as ABF-WPS-D1.5-3110-4. The welding of cover passes was not completed at this location and the work appeared to be in general compliance with contract documents.
